ROCKFALL MONITORING PREONZO

Detailed monitoring and analysis of rock movements by interferometric radar before large rockfall in Preonzo.

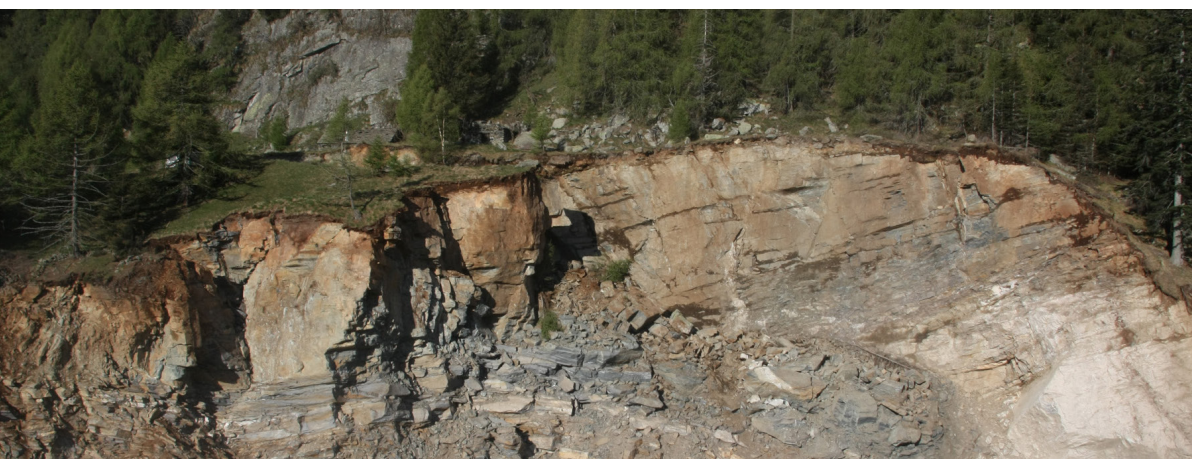
Figure 1: On 15 May, approx. 220,000 m³ of rock debris fell down into the valley.

In the early hours of May 15, approx. 220,000 m³ of rock plunged down the valley for several hours and fortunately did not cause any damage. However, half of the potentially unstable material had remained at the top. Were further events to be expected? How extensive were movements after the first part of the landslide? Since most of the originally mounted monitoring equipment had been destroyed during the event, the interferometric radar had to deliver the answers. We could give an all-clear few hours after the main fall. Some parts of the rupture zone were still moving, but were coming to a halt fast. Secondary rockfall was not to be expected, our work was completed.

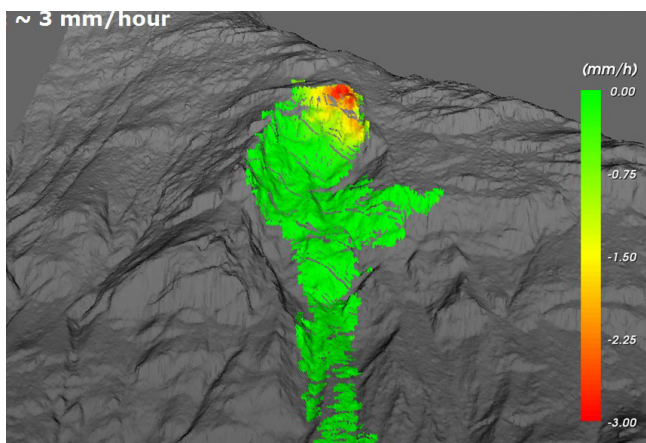
The widespread movement continued throughout the next week, constantly creeping with 4 mm/h until May 13, when accelerations increased dramatically. Analyses predicted the rockfall event to occur late night May 14 to May 15 during the day. These analyses were also automated and provided as live data to local authorities. They evacuated the run-out zone and closed off the cantonal road.

Figure 2: Georadar view: The moving rock mass contains an area of 100 x 200 m.

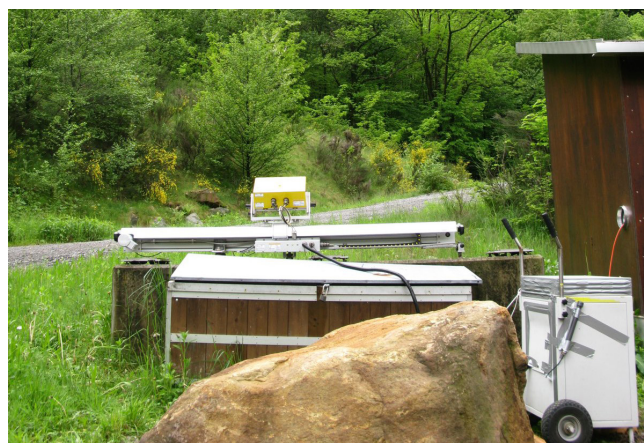
Figure 3: The interferometric radar is located at a distance of approximately 2 km.
