LANDSLIDE MONITORING VAL PARGHERA

Comprehensive monitoring system of the debris flow channel in Val Parghera with automatic warning of the responsible persons via SMS as soon as a predefined limit value is exceeded.

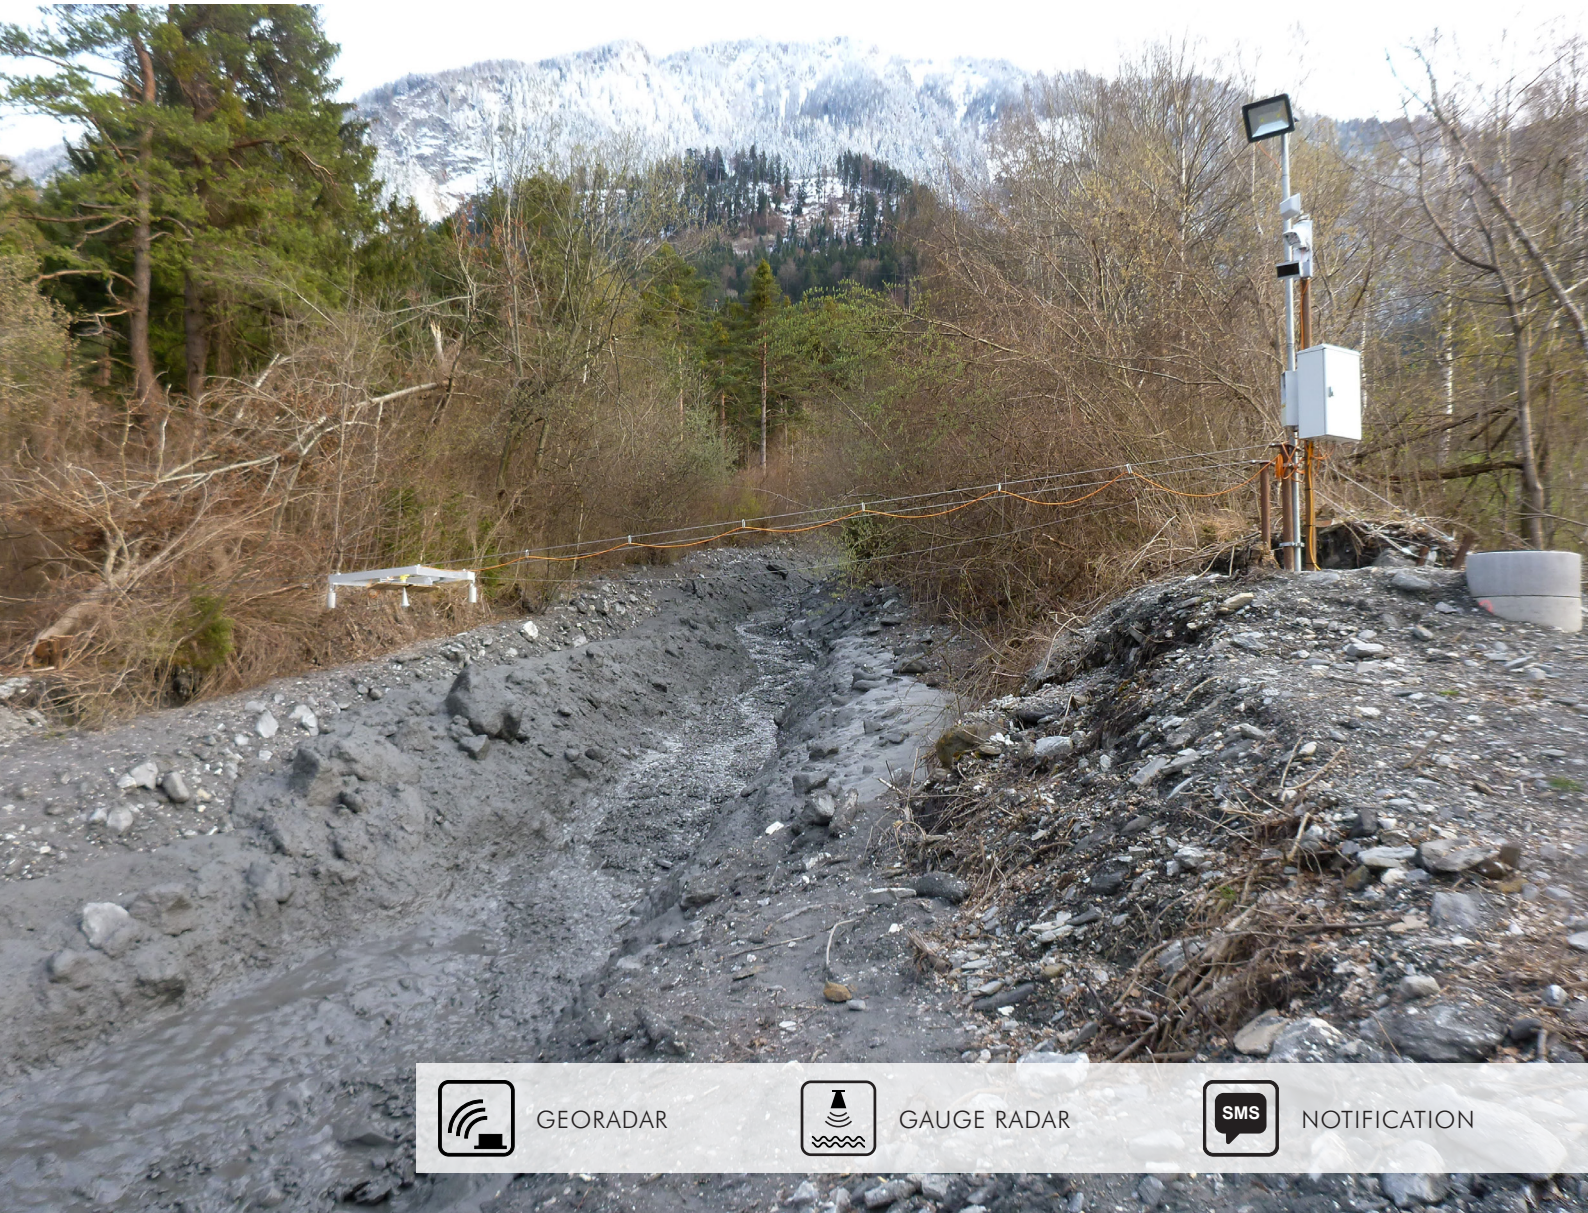
Title Page: View on the radars.

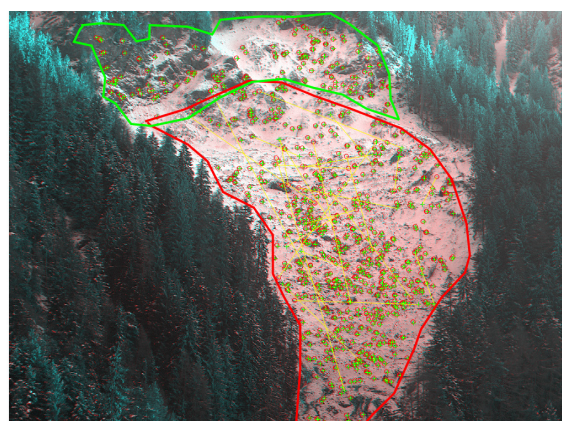
Figure 3: The analysis of the camera images shows flow velocities of the debris flow between 20 cm and 2 m per day.

still moving or unstable material, interferometric radar measurements were carried out in June. The analysis of the camera images as well as the radar data showed that the landslide flowed down the valley with velocities between a few cm and two metres per day. The bedload trap had been extended in case of emergency, because more material continued to accumulate. This material had to be continuously dredged, deposited or liquefied in order to be gradually discharged into the Rhine river. In order to make the work in the bedload trap and the flushing of the drainage channels as efficient as possible and to ensure the safety of the traffic and transport infrastructure, Geoprevent installed additional webcams and gauge radars in August 2013. The authorities were thus able to monitor the landslide, the emergency bridge, the bedload trap and the landslide area at several locations remotely in our online data portal. The online data portal is accessible via desktop, tablet or smartphone and offers an overview of all live and recorded data. In the event of critical level changes, warnings were automatically sent by SMS to enable immediate action to be taken.
